Manhole Inspection Summary

Manhole # S55G__022MH

Location Address: **rear 3810 bank st**

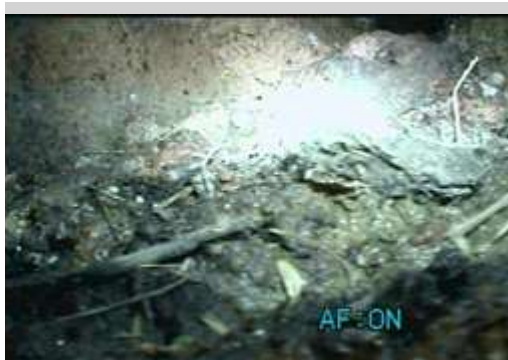
Defect 5

Condition: ☐ Sound ☐ Cracked ☐ Root Intrusion ☐ Deteriorated ☐ Leaks ☒ **Debris**

channel debris

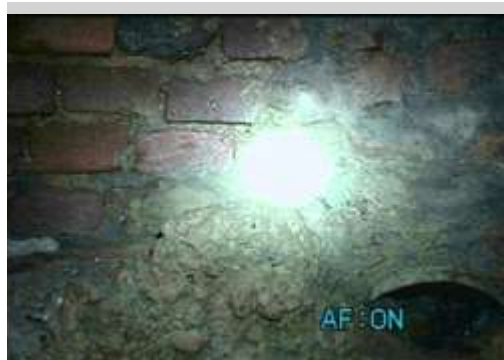
Defect 4

Condition: ☐ Sound ☐ Cracked ☐ Root Intrusion ☐ Deteriorated ☐ Leaks ☒ **Debris**

bench debris

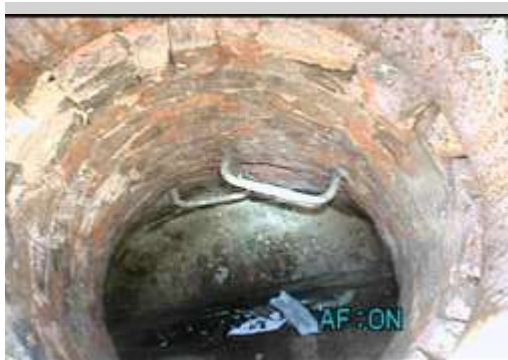
Defect 3

Count: **2** Missing: **0** ☒ **Corroded**

corr steps

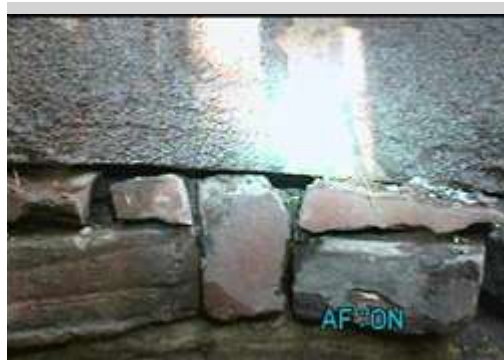
Defect 2

Condition: ☐ Sound ☒ **Cracked** ☐ Root Intrusion ☒ **Loose Brick** ☒ **Deteriorated**

chimney cracked, deteriorated & with loose brick

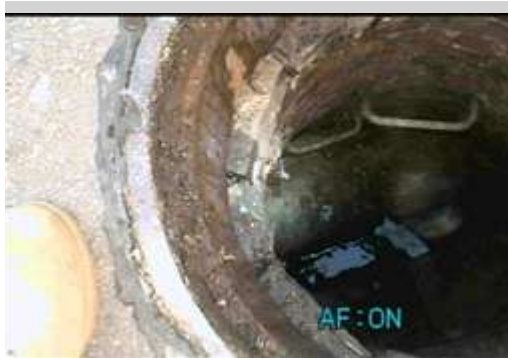
Defect 1

Offset: **2** (in.)

frame offset

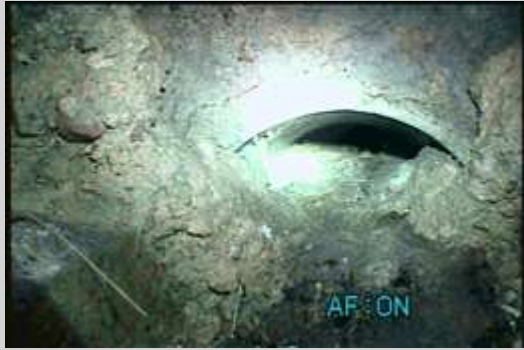
9 O'Clock Inflow

appears to be abandoned; too much debris to see

Deposits: ☐ None ☐ Mud ☐ Sludge ☒ **Debris** ☐ Grease

Silt Depth: 0 (in.) Deposits Extent: **Heavy**
